Summary of Investigations

Pavement investigations were conducted on Route 41 from PM R1.0 to PM R3.0 for cold-in-place recycling. Cores indicate that the engineering properties of these materials may be improved to provide sufficient strength required to extend the life of this pavement for a few years by recycling the upper portion with asphalt emulsion and capping with hot mix asphalt (HMA).

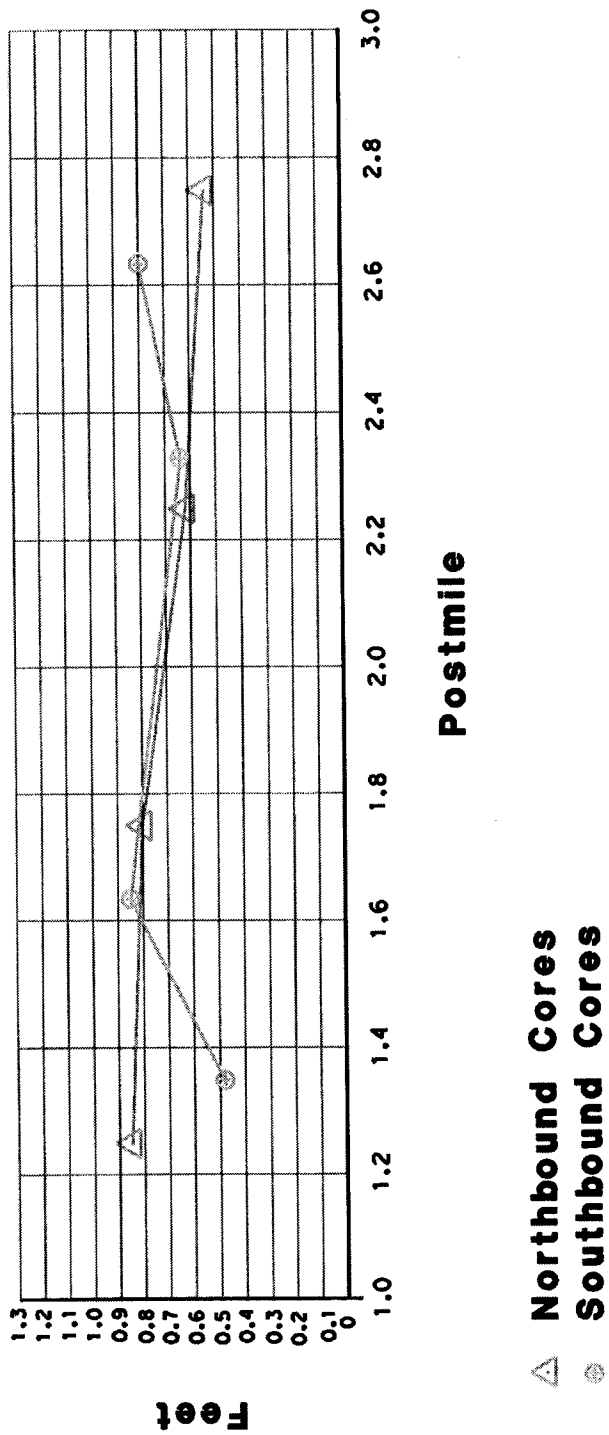
Fre-41 AC Thickness

The general structural section is HMA over aggregate base. At some locations, the base material is native material or cement treated base. Cores indicated a depth of HMA that range from 0.48 foot to 0.85 foot. Core samples taken were not uniform in appearance. Some core samples show fabric materials at the depth of 0.21 foot to 0.37 foot from the pavement surface.
